# Integrated Strategy in Road Assesment for Tameroddo-Majene City Boundary Road Section Preservation

<sup>1</sup>Sudirman, <sup>2</sup>Aswara A. Patandjengi

Universitas Palopo, Indonesia

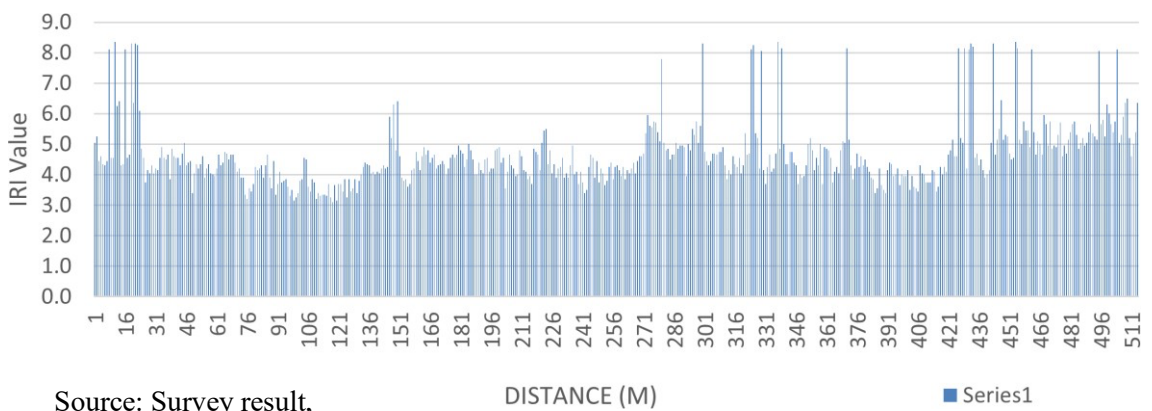
Figure 5. IRI value from Hawkeye for Tameroddo-Majene City boundary road section

The result showed that of 'good' condition was only 5%, of 'fair' condition reached 85%, of 'lightly damaged' was 10%. However, there was no 'heavily damaged' found. Overall assessment value of road conditions based on IRI recapitulation for Tameroddon-Majene City boundary road section can be seen in Figure 5 below:

Figure 5 shows that for the Tamareddo-Majene City boundary road section, the lowest IRI value was

3.0 - 4.0, classified as of 'good' conditions were found at STA 25, STA 37, STA 48, STA 540, STA 58 - STA 59, STA 72 - STA 78, STA 83, STA 85 - STA 87, STA 89 - STA90, STA 92 - STA 102, STA 105 - STA131, STA 138, STA 151 - STA 155, STA 173, STA 187 - STA 188, STA 202, STA 207 - STA 208, STA 213 - STA 215, STA 227, STA 231, STA 233, STA 236, STA 238, STA 240 - STA 241, STA 246, STA 248, STA 251 0 STA 251, STA 259, STA 291, STA 311, STA 313, STA 330, STA 346 - STA 349, STA 358, STA 363, STA 373, STA 382 - STA 385, STA 387 - STA 389, STA 393 - STA394, STA 396 - STA 399, STA 401 - STA 405, STA 408 - STA 411, STA 414 - STA 415, STA 417, and STA 438 - STA

439. While the road segment classified as 'heavily damaged' conditions was zero (0). The highest IRI value was 8.1 - 8.4 classified as 'slightly damage' were found at STA 700, ST A 1000, STA 1500, STA 1800, STA 2000 - STA 2100, STA 29900, STA 23200 - STA 23400, STA 32800, STA 33600, STA 33800, STA 37000, STA 42500, STA 42800, STA 43000 - STA 43200, STA 42200, STA 45300 - STA 45400, STA 46100and STA 49400.

Average IRI value obtained was between 4.0 - 6.0, classified as 'fair' conditions. The road conditions in percentage (%) are described in the following pie charts (data was taken from Semester I and Semester II in 2021).

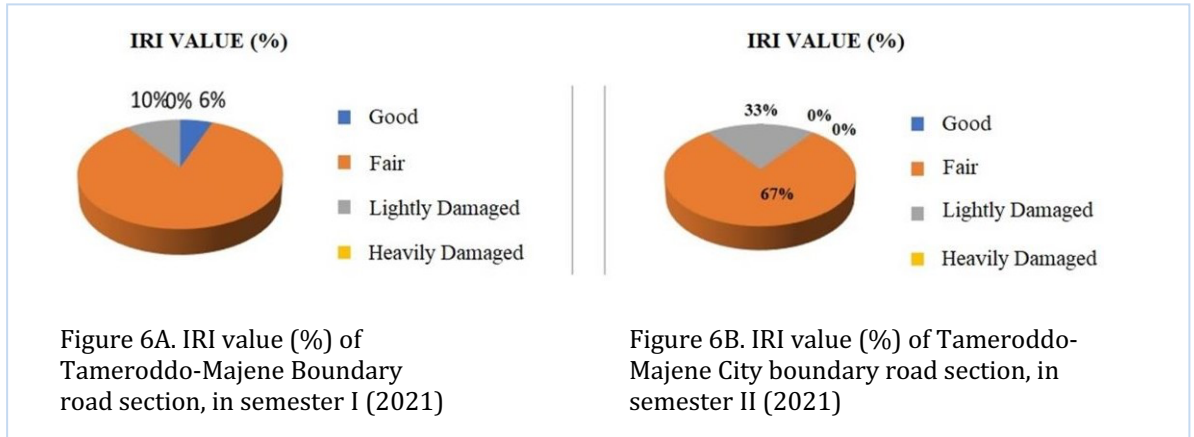
Figure 6 shows that based on IRI measures, road conditions in percentage (%) for the Tomareddo- Majene City boundary road section in Semester I (2021), that of good condition was only 6%, of 'fair' condition reached 84%, of 'lightly damaged' was 10%. However, non (0%) in 'heavily damaged' was found. In Semester II (2021), that of in good condition was 0%, of 'fair' condition reached 67%, of 'lightly damaged' was 33%, and 'heavily damaged' was 0%.

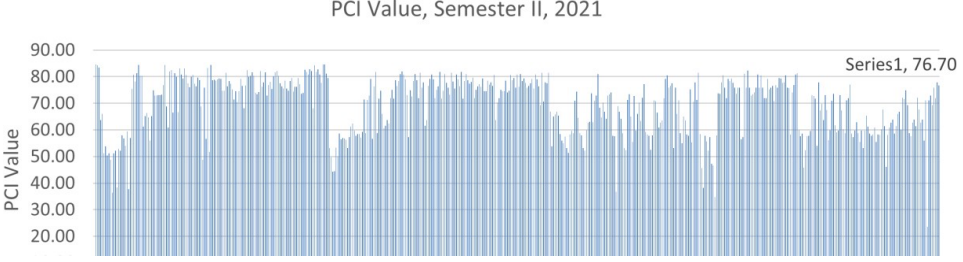
Figure 7. PCI Value for Tameroddo–Majene City boundary road section

Based on PC I measures, road segments of 'medium' condition was 29%. Neither of the road segments was in 'lightly damaged', nor in seriously damaged were found. Recapitulation of road conditions for Tameroddon-Majene City boundary road section can be seen in Figure 7. It shows that the lowest value was between 36.45 – 40.00, classified as 'bad' conditions was found at STA 1100, STA 1400, STA 2100, STA 14500, STA 31700, and STA 50600.

Road conditions classified as the highest value was between 71.50 – 85.00, classified as of 'good' conditions was found at STA 0 – STA 300, STA 230 – STA 290, STA 360 – STA 430, STA 460 – STA 470, STA 4900 – STA 6400, STA 6700, STA 6900, STA 7100 – 7655, STA 9200 – STA 13200, STA 16400, STA 16600 – STA 16900, STA 1700 – STA 17100, STA 17300 – STA17400, STA 1800 – STA 1900, STA 19200 – STA 20000, STA 20300 – STA 24300, 24500 – STA 27000, STA 27100 – STA 27600, STA 29200 – STA 29300, STA 30200, STA 30400 – STA 30600, STA 30900, STA 31200 – STA 31400, STA 32400 – STA 32500, STA 32800, STA 32800, STA 33100, STA 33300 – STA 33400, STA 34000 – STA 34100, STA 34600 – STA 35200, STA 35500, STA 36200, STA 36400 – STA 36600, STA 37900 – STA39200, STA39500 – STA 42200, STA 42400 – STA 42700, STA 43600 – STA43900, STA 44400, STA 44800 – STA 44900, STA 45300, STA 45700 – STA 45900, STA 49100 – STA 49300, STA 50000, STA 50500, STA 50700 – STA 50800, and STA 51000 – STA 51300.

Road conditions classified as 'fair' with PCI value of 43.30 – 54.80 were found at STA 600 – STA1000, STA 1200 – STA 1300, STA 1500 – STA 1600, STA1900, STA 6600, STA 7000, STA 14300 – STA 14800, STA 27800, STA 28700 – STA28800, STA 29700 – STA 29800, STA 32200 – STA 32300, STA 33800, STA 35200, STA 36900, STA 37300, STA 37500 – STA 37600, STA 43100 – STA 43200, STA 43900, STA 46700, and STA 48100. While road conditions classified as 'medium' condition with PCI value of 56.20 – 68.10 were found at STA 600 – STA 1000, STA 1200 – STA 1300, STA 1500 – STA 1600, STA 1900, STA 6600, STA 7000, STA 14300 – STA 14800, STA 15400, STA 27800, STA 28700 – STA 28800, STA 29700 – STA 29800, STA 32200 – STA 32300, STA 33800, STA 35200, STA

36900, STA 37300, STA 37500 – STA 37600, STA 43100 – STA43200, STA 43900, STA 46700, and STA 48100. Based on PCI measures, the average value was 81.75. Thus, overall the road condition was categorized as ‘good’ condition.

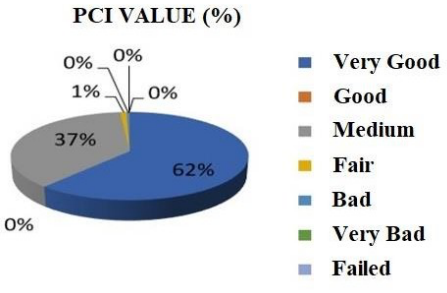
Figure 8A. PCI Value (%) for Tameroddo – Majene City boundary road section in Semester I 2021

Figure 8 shows that in semester I (2021), road segments with ‘very good’ condition was 62%, while in semester II (2021) it became 0%, at the same time, for some road segments, their condition decrease from ‘very good’ to simply ‘good’ were 66%. Road segments in ‘medium’ condition in semester I reached 37%, but in semester II it decreased to only 34%. In semester I, road in ‘fair’ condition was only 1%, however in semester II, it became 0%.

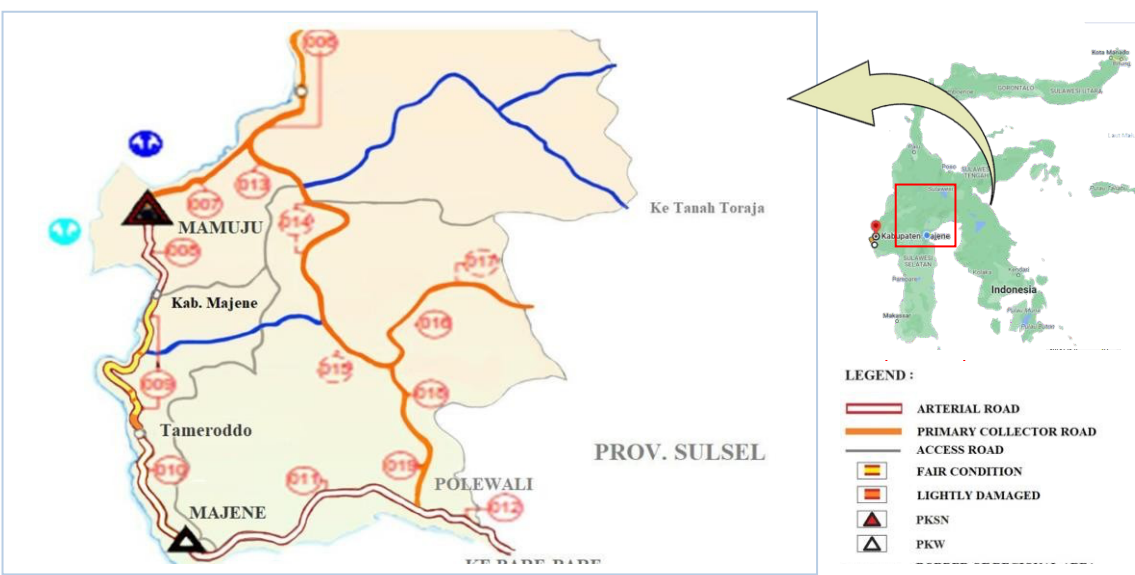
Figure 9. Road Condition of Tameroddo-Majene City boundary road section

Based on road assessment result by IRI measures, the road conditions can be seen in the following map. Road segments marked with orange color indicates of 'slightly damaged' condition, while those marked with yellow color indicates of 'fair' condition.
